Firewise Communities / USA

Community Assessment Report for Gold Mountain

Plumas County, California

April 25, 2012

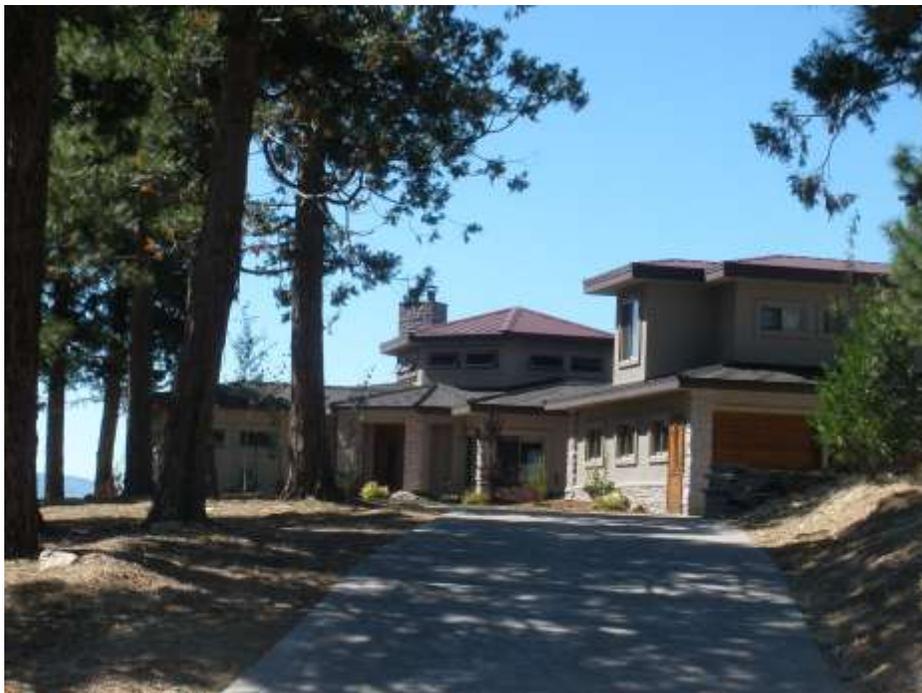
GM Home with Defensible Space Zone

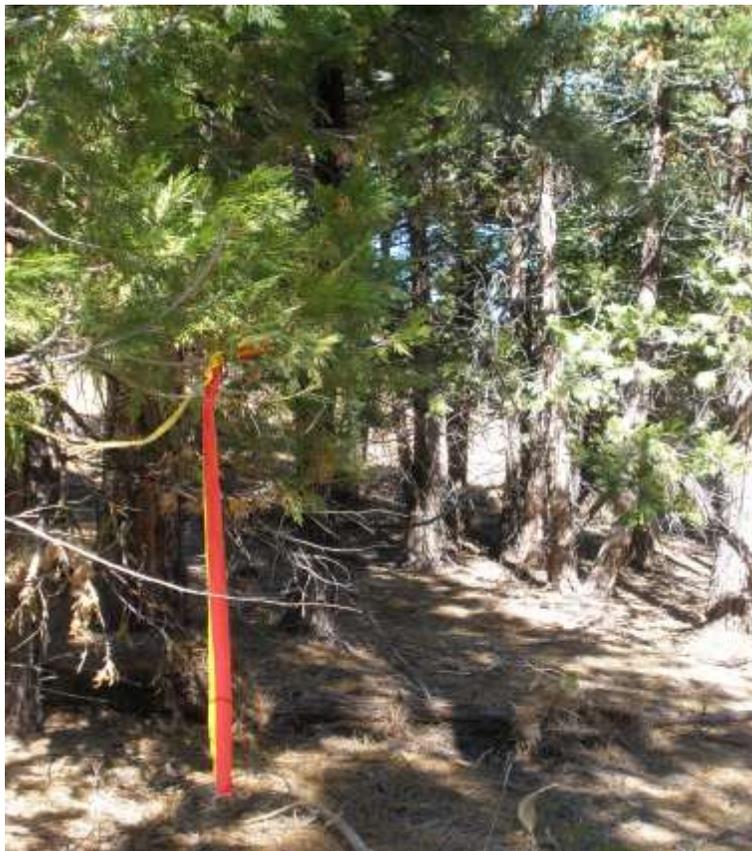
Area marked for 2012 mastication project

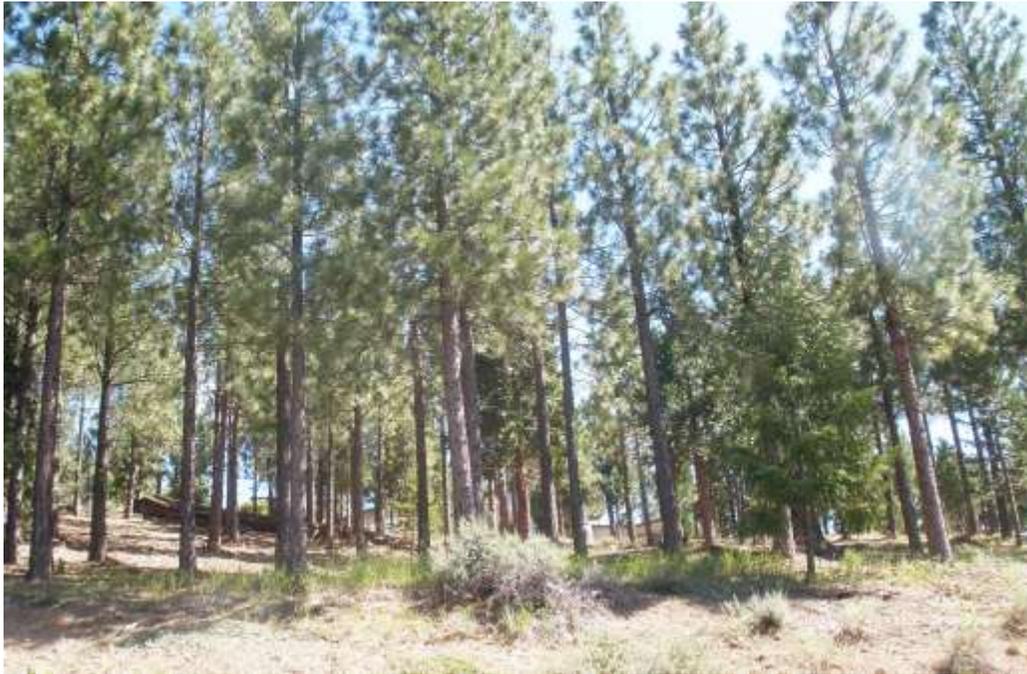
Common area with HFR completed - 2009

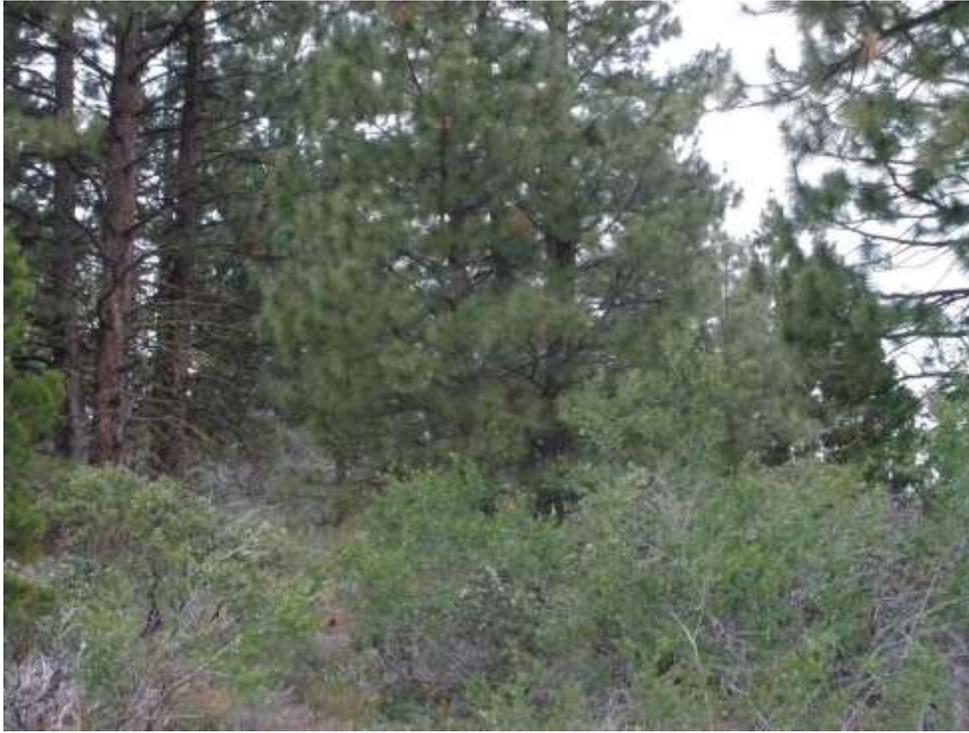
Typical forest 'before' fuel break project

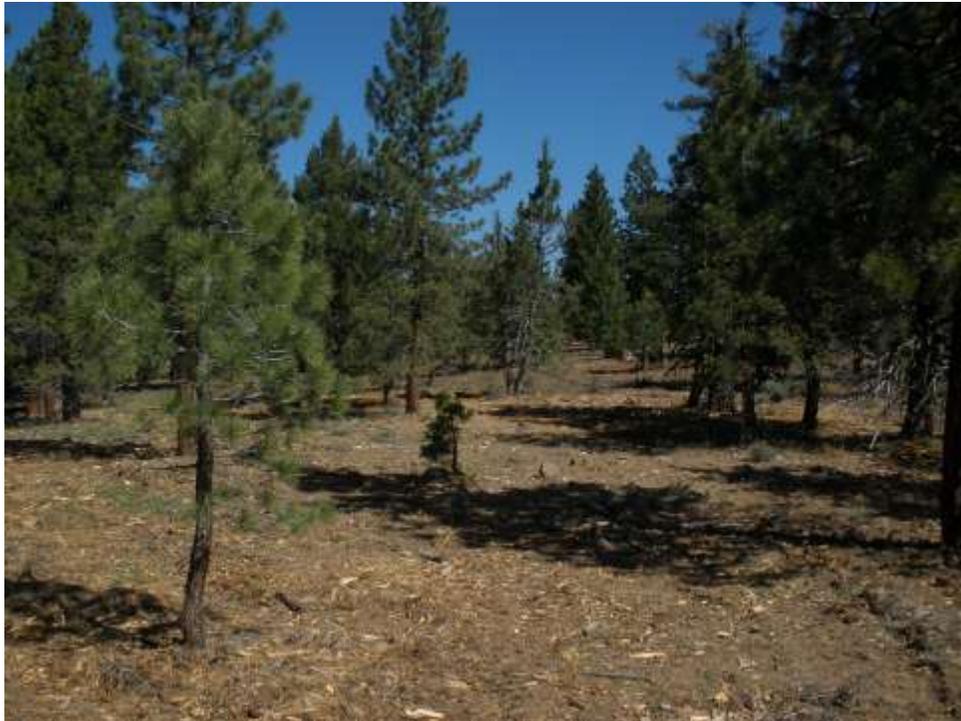
Typical 'after' fuel break project
